# UNIVERSITY OF FLORIDA

## LABORATORY TESTS OF MILITEC-1

The following three tests were done by the **Materials Science Laboratory of the University of Florida** showing the results of a comparison of metal surfaces with and without MILITEC-1 treatment. The text below is an attempt to describe the results in terms that less technical people can understand while more technical people can appreciate.

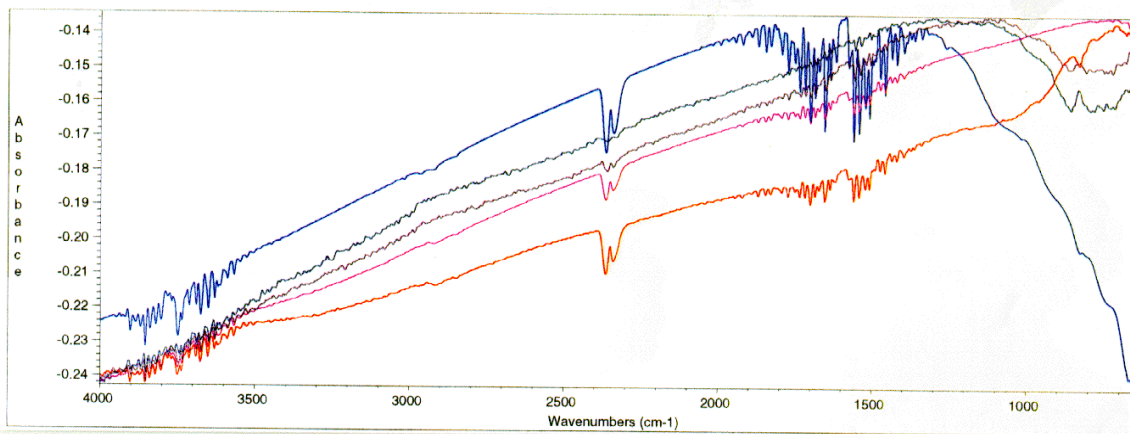
This test used the same metal surfaces that were tested with Atomic Force Microscopy, but here the treated and untreated surfaces were examined across the spectrum to see what chemicals were present on the metal surfaces. The metal surface treated with **MILITEC-1** had received the treatment many months before this test and the metal had been exposed to the atmosphere throughout this period. Even during the test, the metal was exposed to the atmosphere in the laboratory. The most telling part of the test result is in the wavelength area between 1300 and 1900 and equally between 3500 and 4000. The jagged lines represent the presence of water. The top line and the bottom two lines are untreated surfaces while the other two are treated. **The two lines for the treated metal show minimal presence of water. The MILITEC-1 has affected the metal surface so that water is not readily attracted** (typical bare metal attracts water which can lead to rust). This test result helps to explain the ability of **MILITEC-1 to reduce rust and corrosion.** The double dip in the center of the graph is CO<sub>2</sub>.

This test was performed using an IR Nicolet Magna IR Spectrometer model 750.
